GALLINAS BRIDGE PROGRESS

1 AUGUST 2017

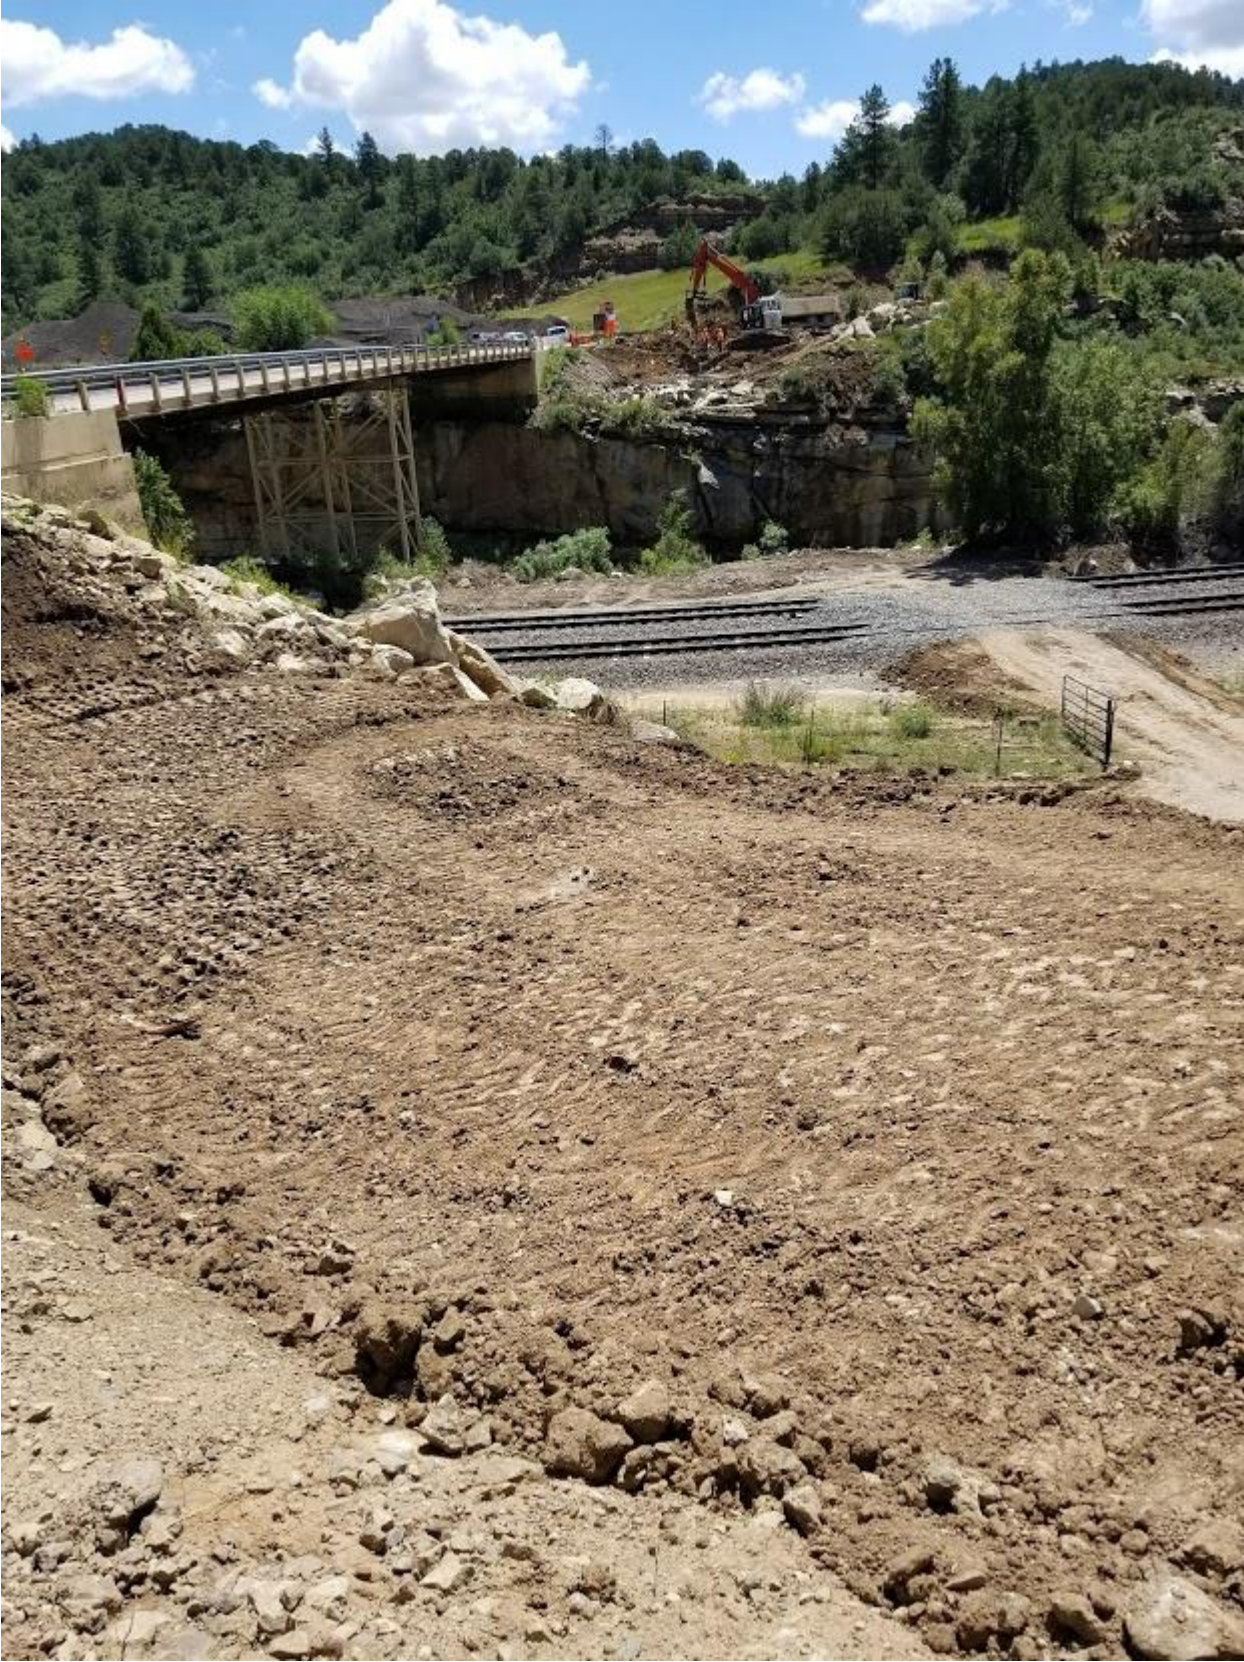
The first picture below is looking East from the West side. It shows the excavation and preparatory work for the East abutment, the drill rig pad for the center support pillars, and the drill rig pad for the East abutment pillars.

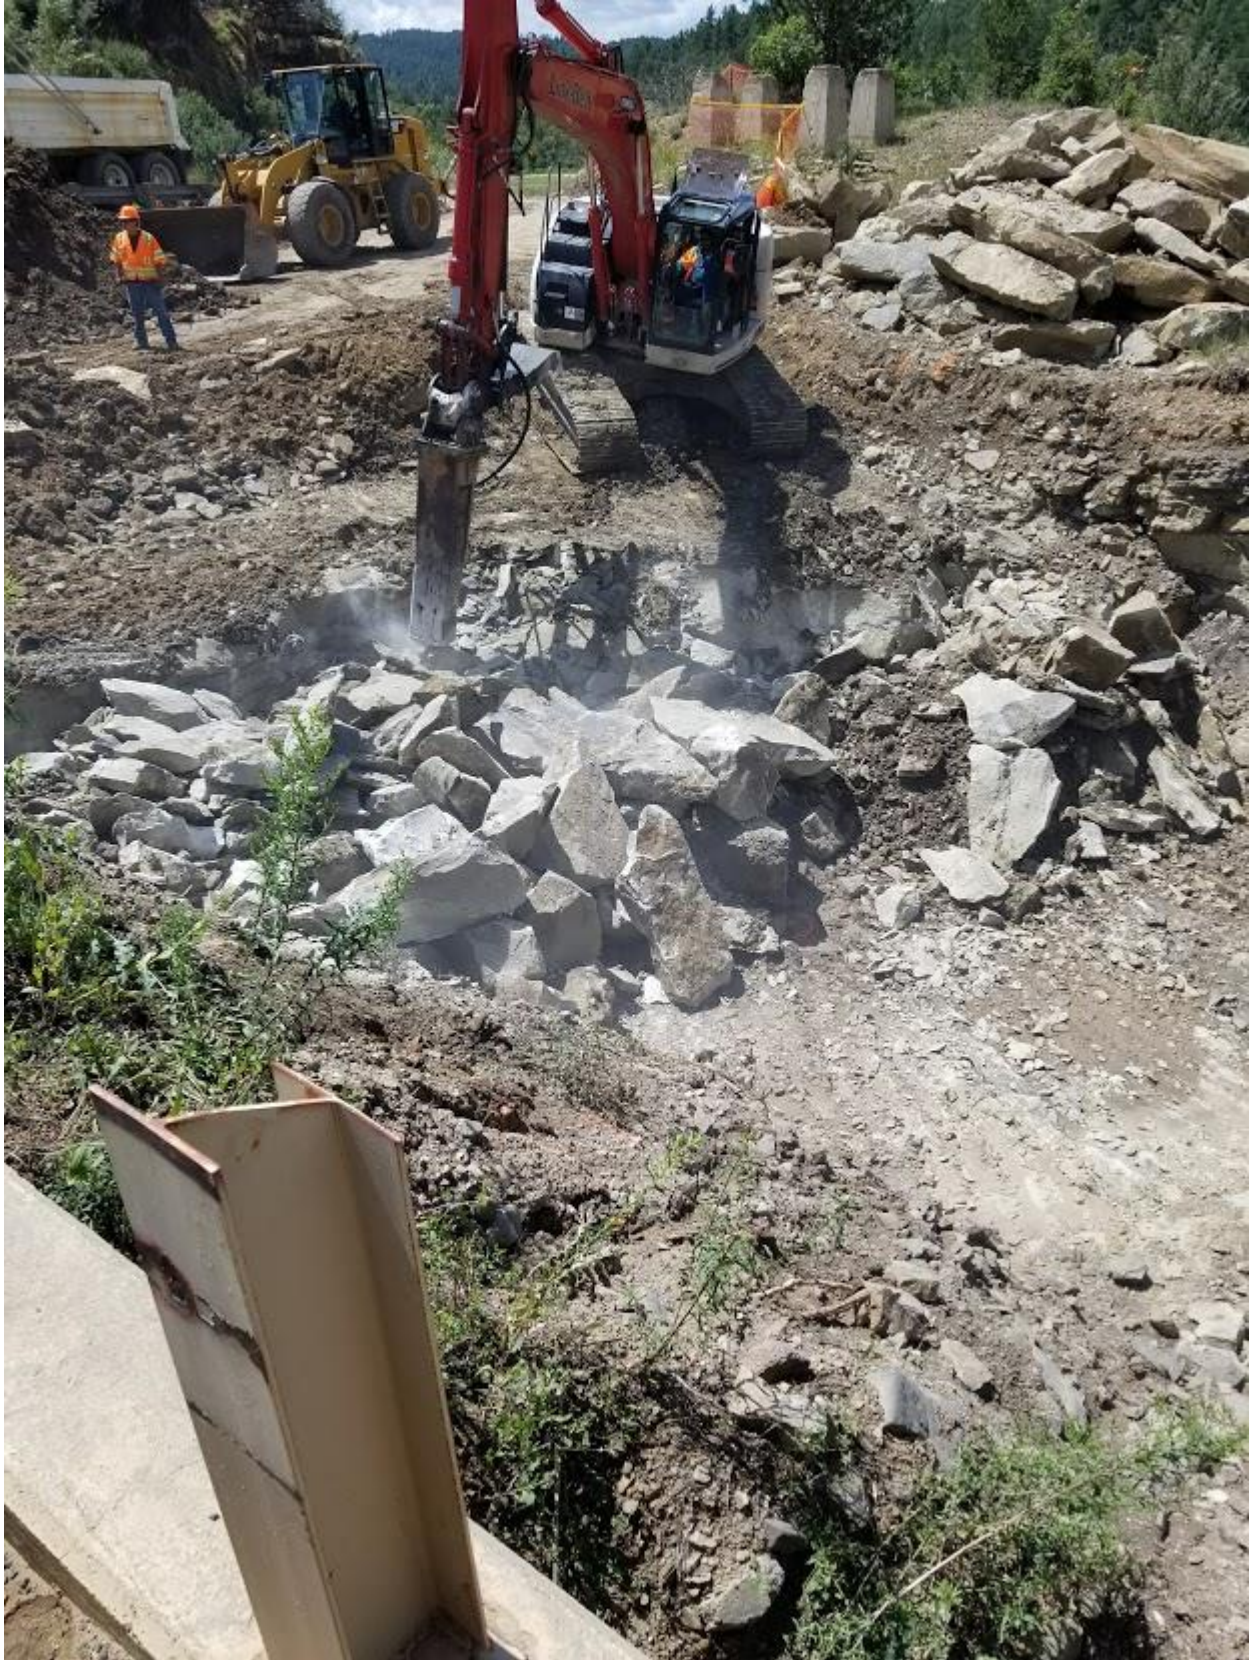
The second picture below shows the excavator with the hydraulic hammer attachment breaking up solid rock to get to the final grade for that abutment.

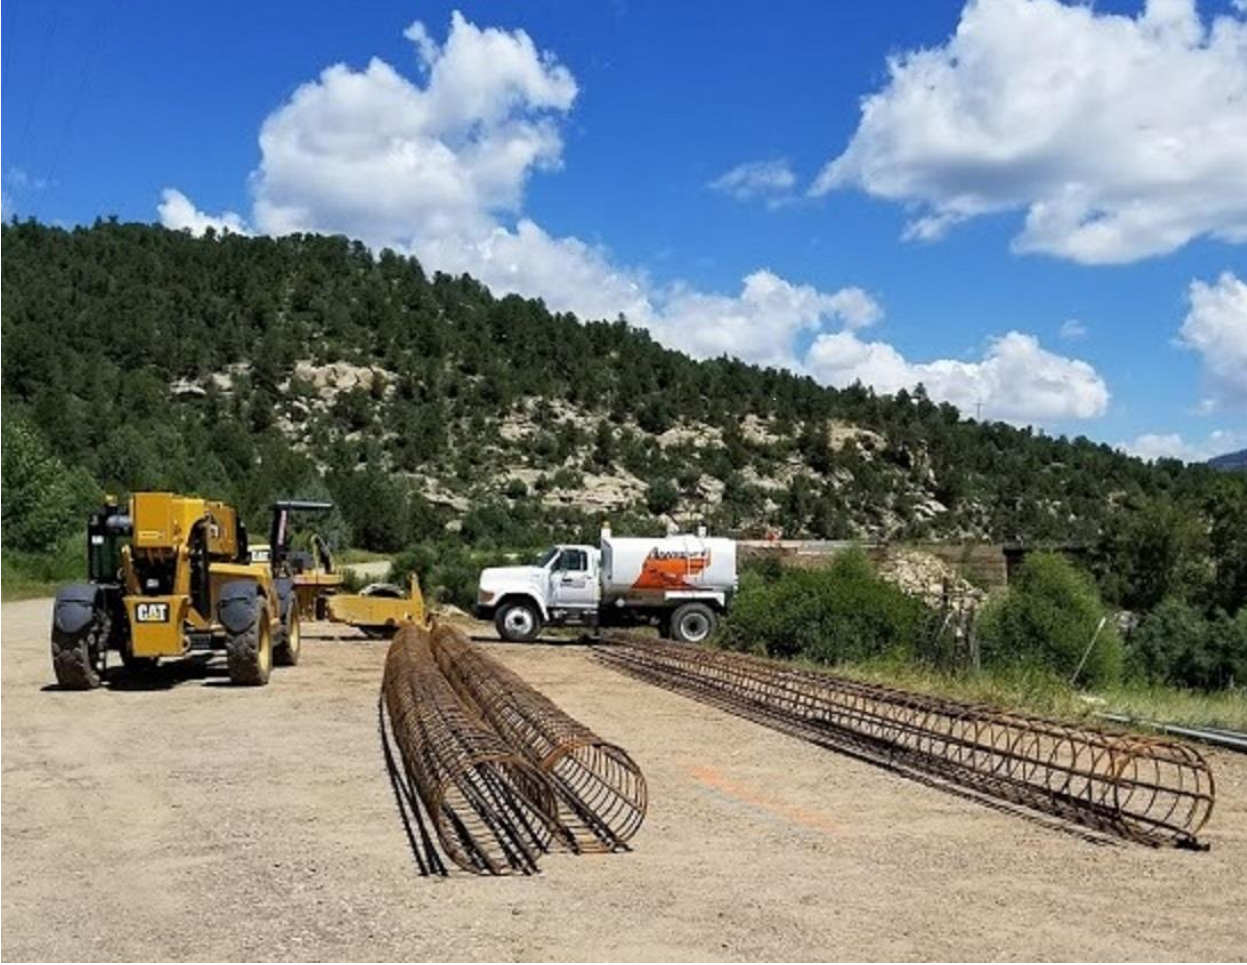
The third picture below shows the three rebar cages that will be placed inside the West pillar holes before the concrete is poured around them.
